Fire Aboard the M.S. SCANDINAVIAN SEA
on March 9, 1984
Technical Assessment

USCG CITS-85-1-1

14. Sponsoring Agency Code		15. Supplementary Notes This technical report was prepared as background material for the Marine Board of Investigation that examined the SCANDINAVIAN SEA FIRE of March 9, 1984.

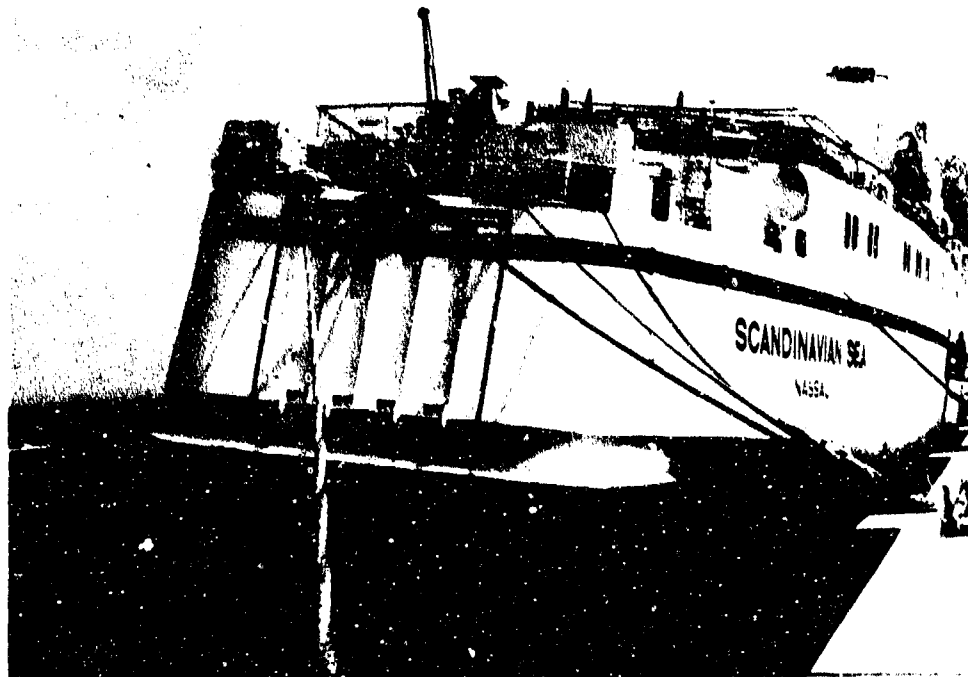
Firefighting operations were delayed at various times as a result of a list that developed as large quantities of water were pumped into the vessel to extinguish the fire and to cool decks above "A" deck. Photograph 4 is a view from the stern showing the list.

Photo 4 - SCANDINAVIAN SEA listing to starboard

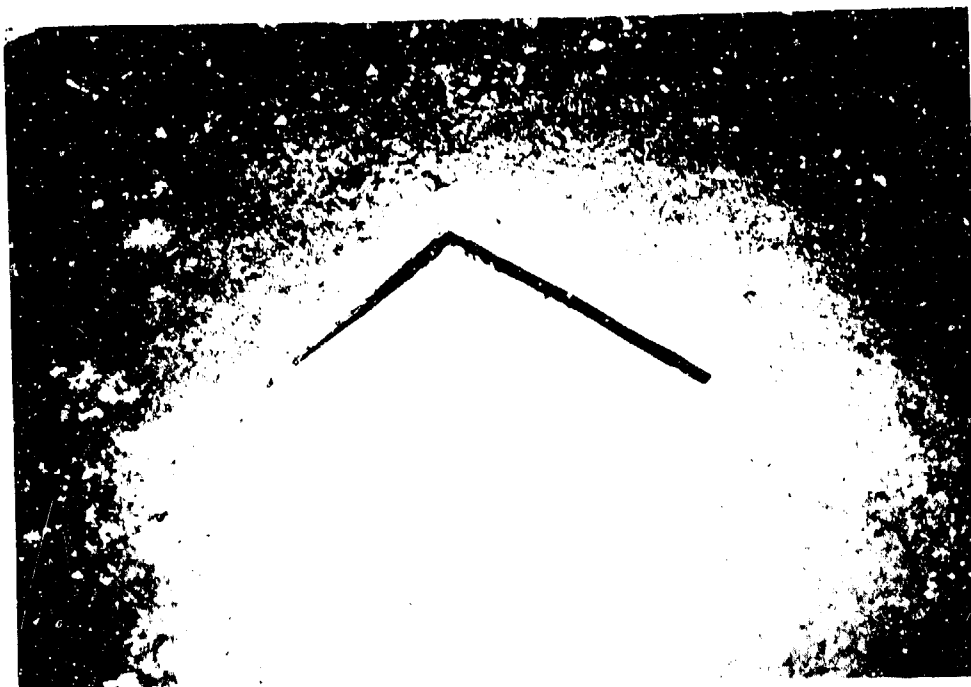
Photo 20 - Deck in restaurant

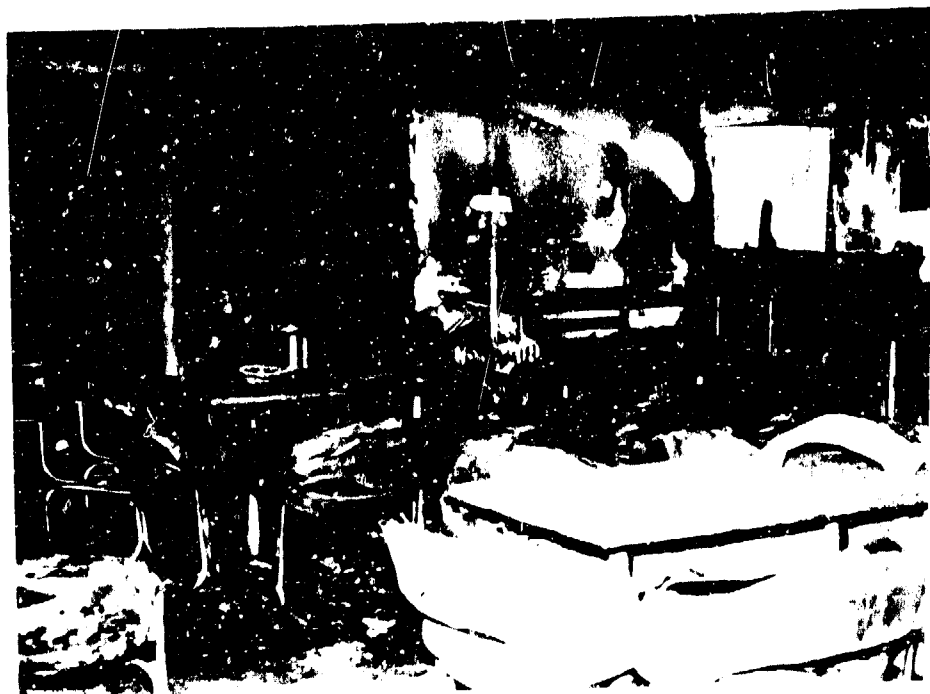
Photo 21 - Restaurant Lounge deck
